Above Ground Gamma Ray Logging of Edgemont, South Dakota and Vicinity

Technical Note
ORP-LV-80-2

February 1980

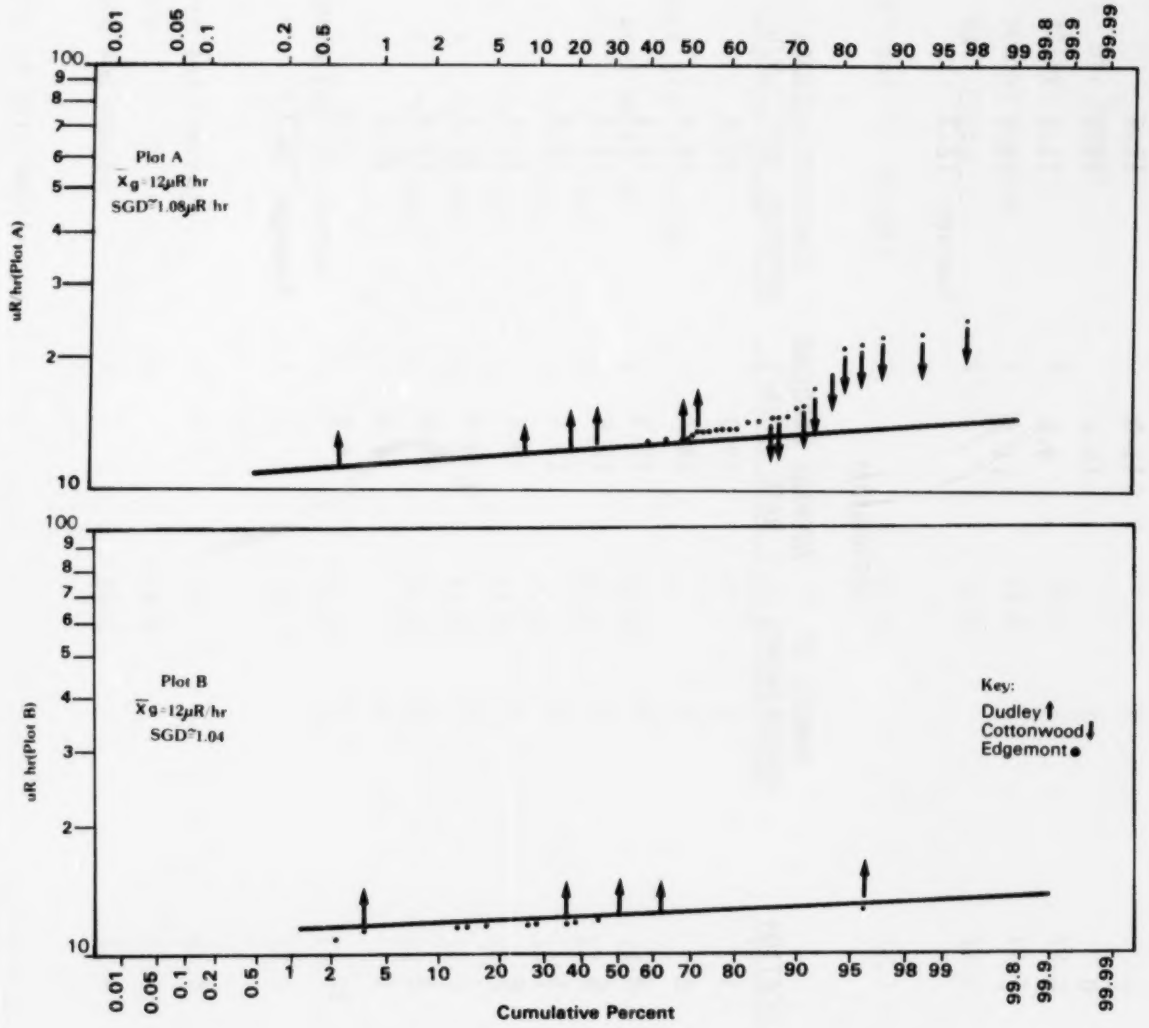
Figure 3. Log-Probability Plot of PIC Measurements

All corrected exposure rates are plotted on log-probability paper to determine their distribution characteristics (Figure 3, Plot A). The data on plot A belongs to two distributions which end and begin near the 70 percentile line. All data below the 74 percentile line were ranked and plotted (Plot B). The slope or Standard Geometric Deviation (SGD) of Plot B is 1.04 and strongly indicates that the data in this group indicates background conditions (Denham, 1975). A relatively uniform deposition of mill wastes over the Edgemont area would also produce a similar SGD. The geometric average ($\overline{X}g$) or 50 percentile value for Plot B is about 12 μR/hr. Therefore, the ambient gamma radiation background in Edgemont and Dudley was about 12 ± 1 μR/hr at the 95 percent confidence level. The geometric average compares well with the arithmetic average of 12.4 μR/hr computed in Table 3.

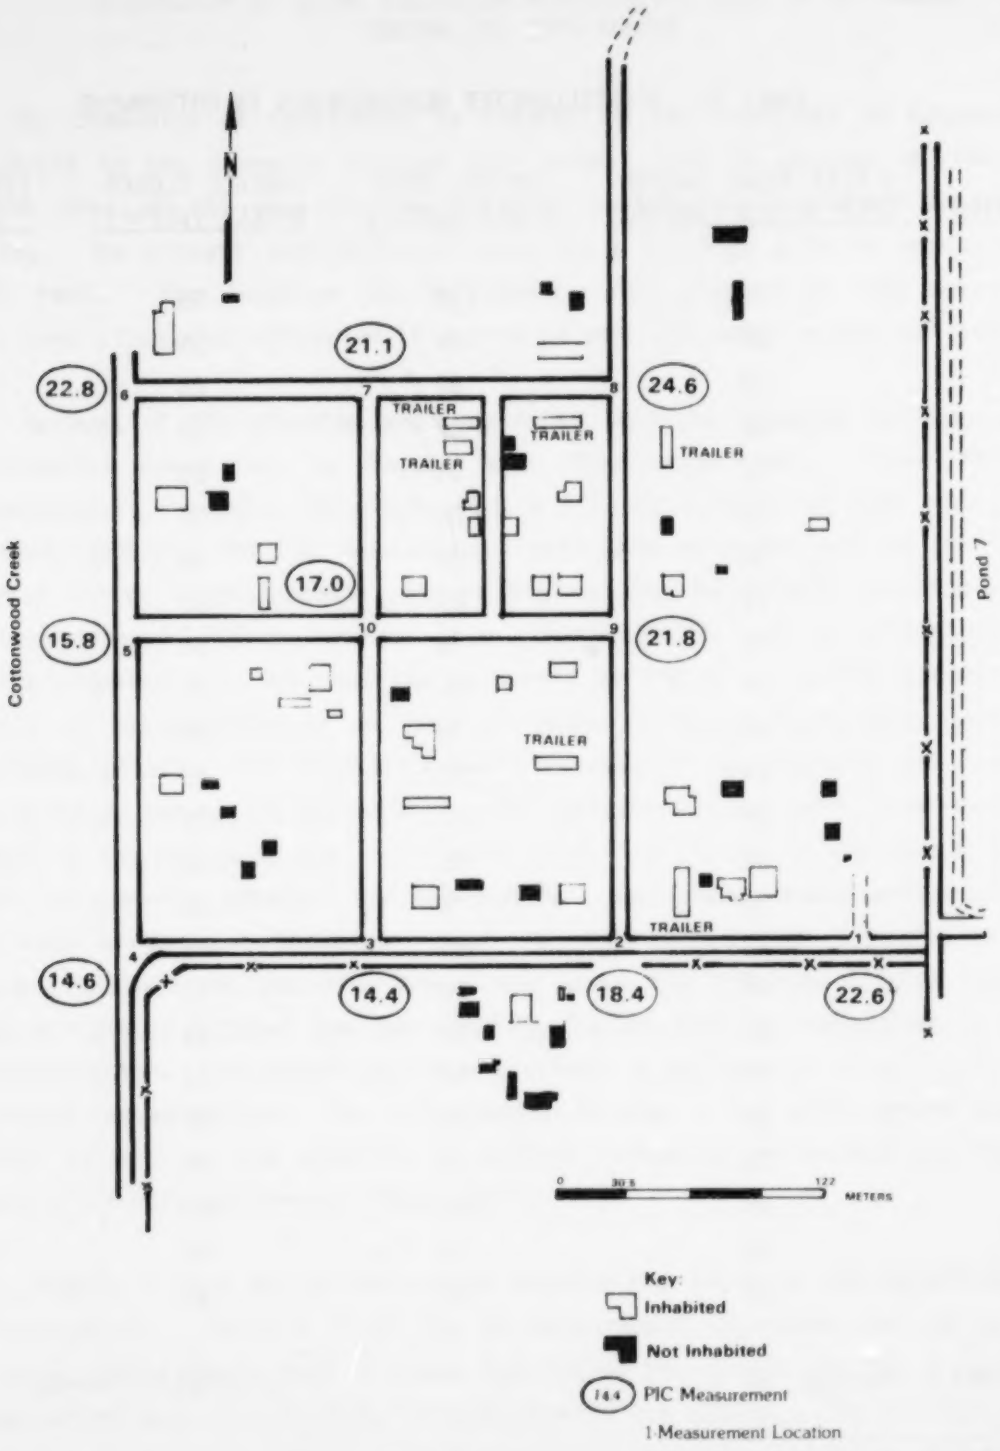
Figure 5. Gross Corrected PIC Measurements in Cottonwood

Gamma radiation surveys in Cottonwood indicate that this area has elevated surface contamination as a result of wind and water erosion of the nearby tailings piles. All structures in Cottonwood may be considered as tailings locations. The estimated average net gamma external exposure rate for the inhabited areas of Cottonwood is 158 mR/yr, ranging from 53 to 412 mR/yr. This does not mean, however, that gamma radiation is the only source of radiation exposure to persons living in the vicinity of the mill site. Inhalation and ingestion of airborne tailings and radon progeny will also contribute to additional human exposures. These exposure sources should be fully evaluated.

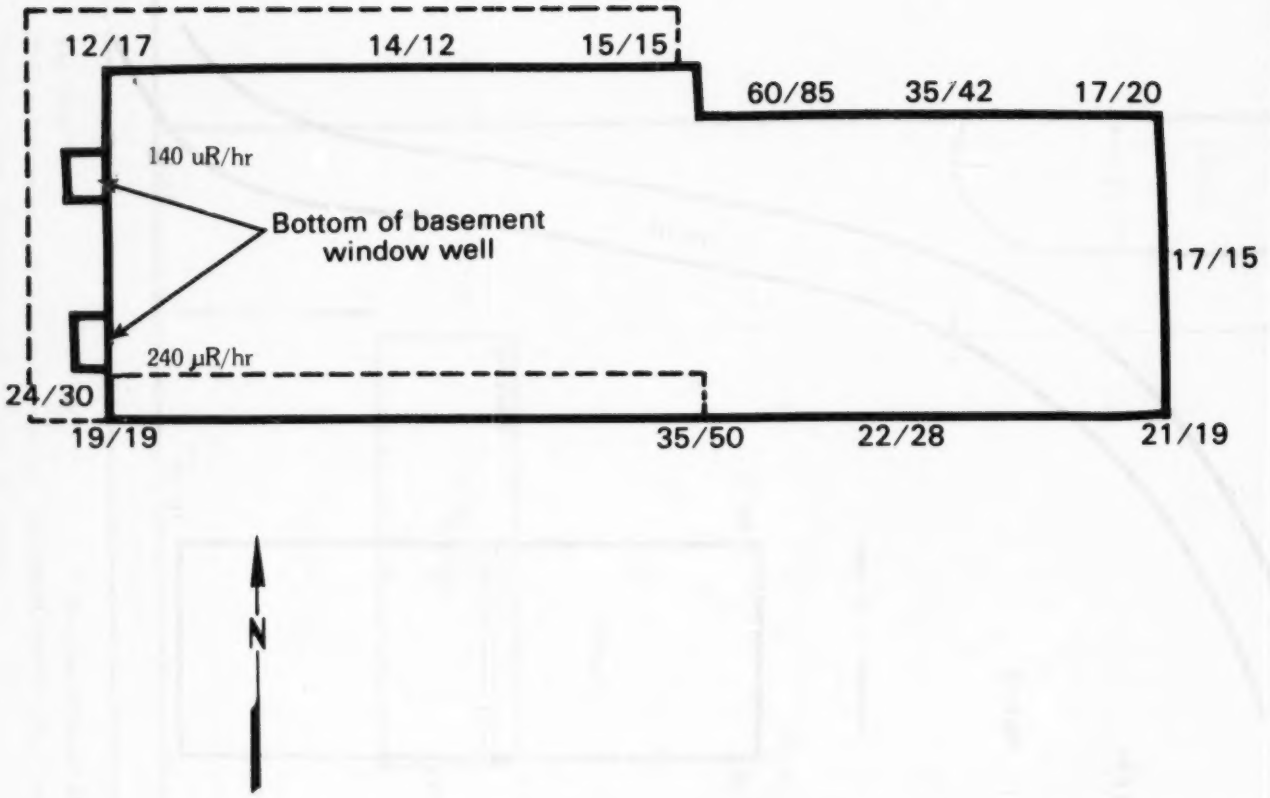
Figure A-2-c. Location 7811-80 - Outside of House

NOTE: SANDSTONE USED IN FIRE PLACE, YARD AND AROUND HOUSE MEASURED 75 µR/hr AT CONTACT.

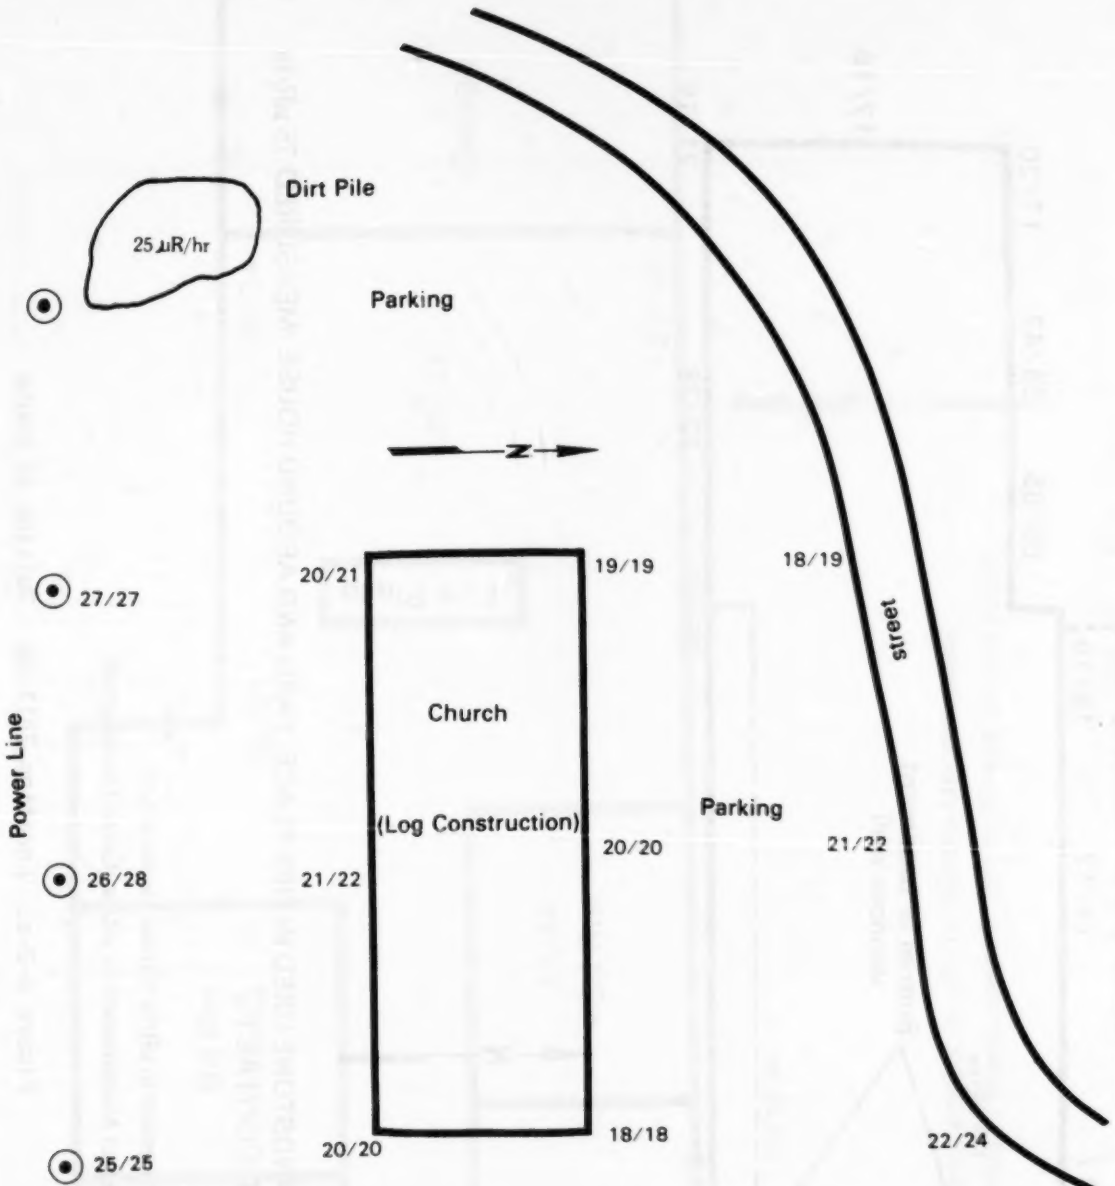
Figure A-3. Location 7811-81

Some large open areas showed significant gamma radiation differences as compared to the general background. Locations 7811-81, 7811-83, and 7811-84 were examples of these differences. Location 7811-81 was a newly constructed log building located approximately in the center of a parking lot. The parking lot had been scraped and cinders added as a top cover. The gamma measurements increased toward the south side and northeast edge of the parking lot. A pile of scrapings was located at the extreme west edge of the lot, and a gamma measurement taken on top of the pile was 25μR/hr. One commercial enterprise west of Edgemont on Highway 18 had a large scraped area with a metal building located on it. When the mobile scanner was driven into the lot the count rate dropped from about 600 counts per second (c/s) to about 400 c/s. The measurements made at both scraped areas tend to indicate the presence of surface contamination. Locations 7811-83 and 7811-84 showed significant increases above the general background. These two areas were generally undisturbed and were covered with grass and weeds. Table 2 is a listing of the anomalies identified during the 1978 survey. Appendix B gives the physical location of the anomalies in Edgemont and Appendix C gives the physical location of the anomalies in Dudley.

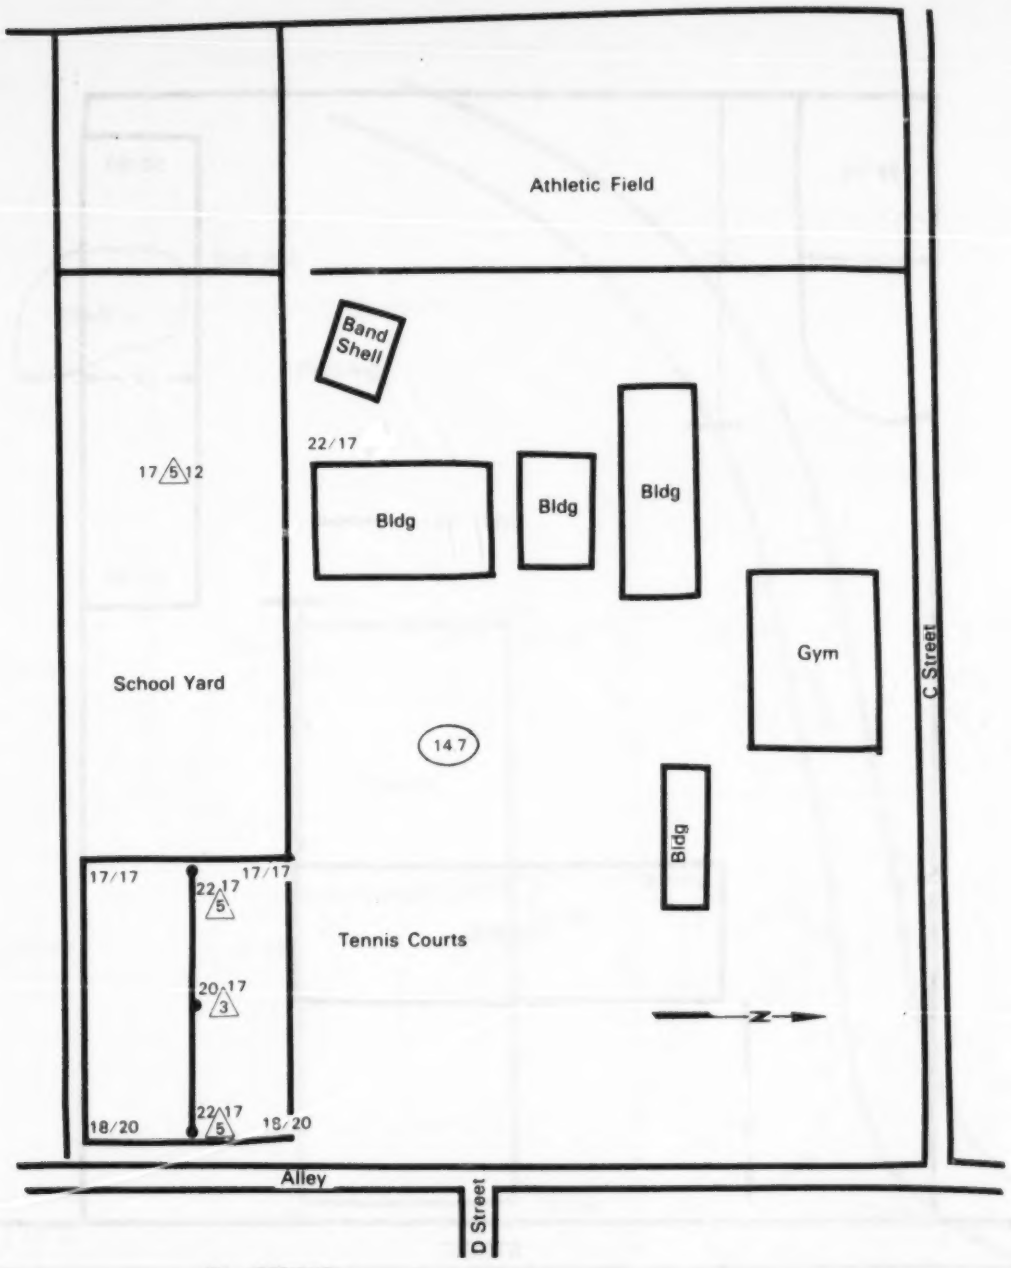
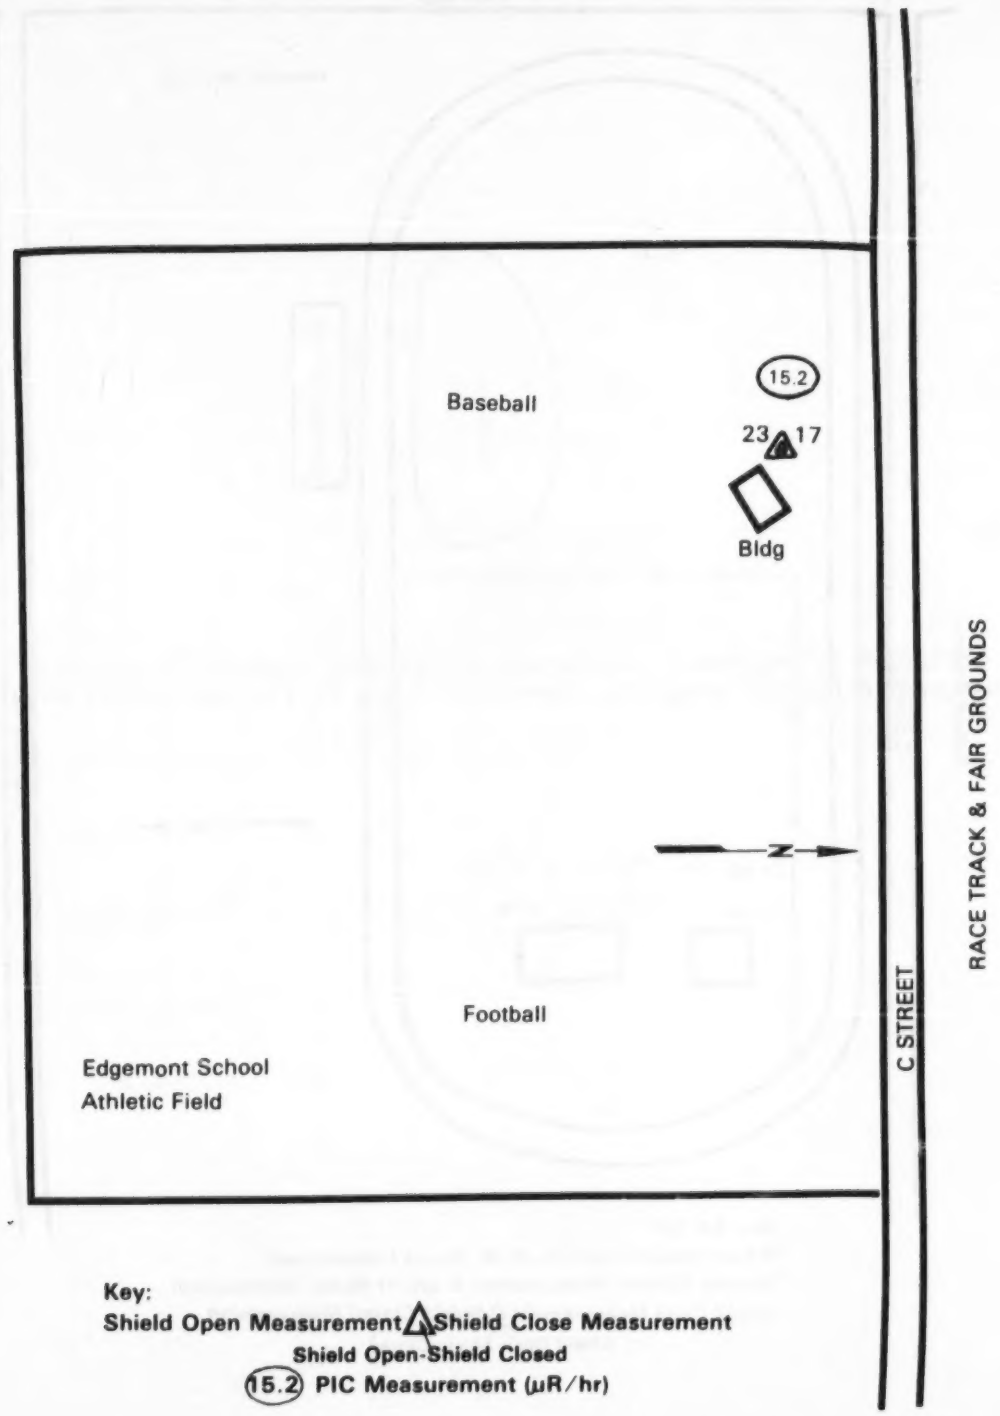
Figure A-5-a. Location 7811-83 & 7811-63 - Edgemont School Area

Locations 2, 4 and 5 above are on the school complex which has suspected mine waste use. Locations 1 and 3 are probably caused by gamma radiation from adjacent anomalies. The cause of elevated gamma exposure rates at locations 6 and 7 is not known.

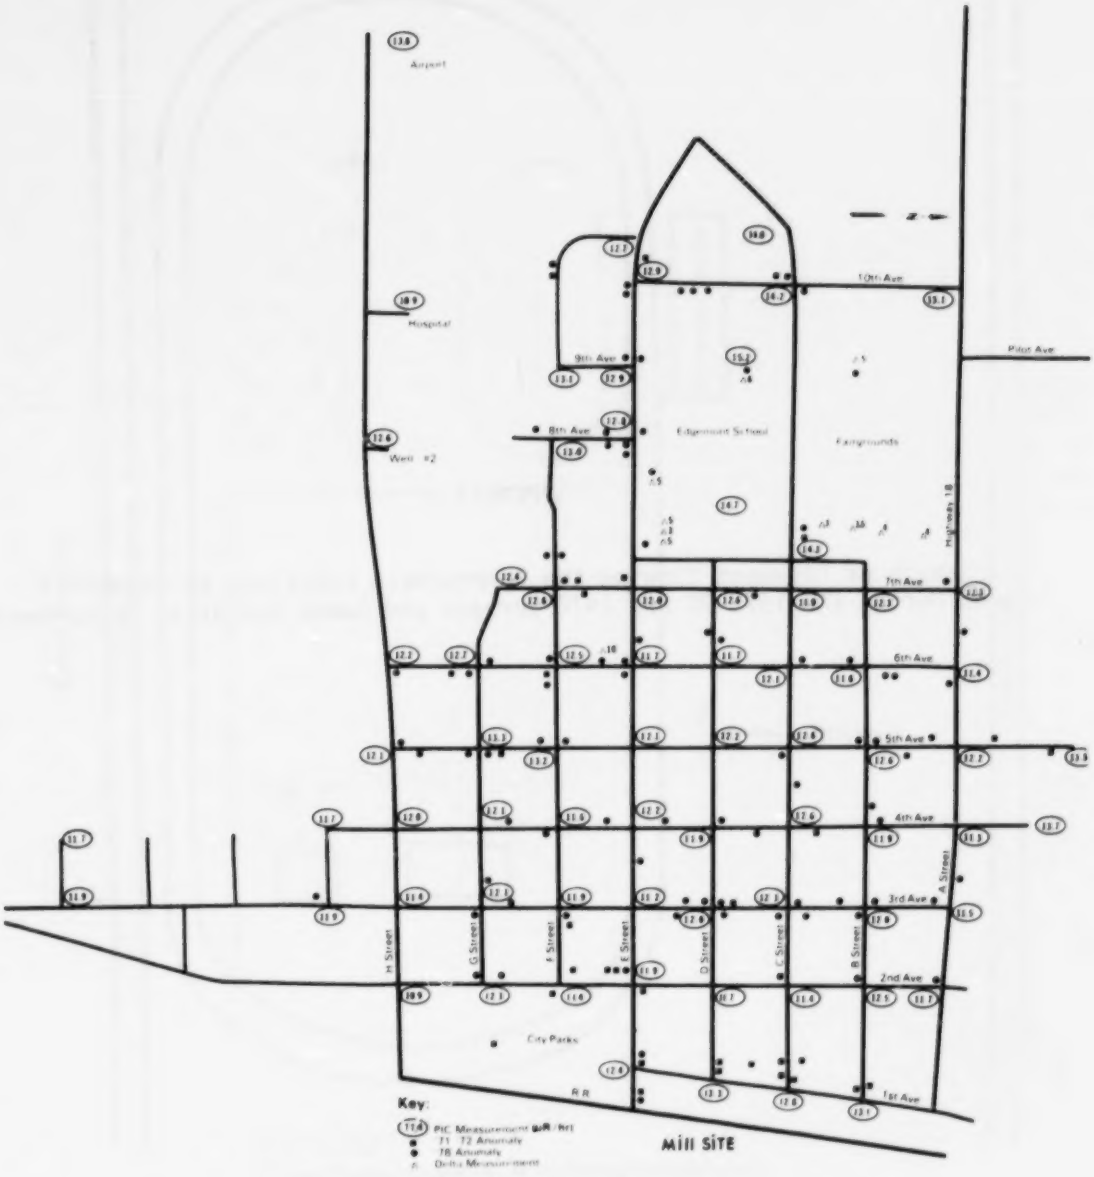
Figure B. Edgemont

Sketch of Edgemont Showing the Approximate Locations of Anomalies
Found During the 1971-72 and 1978 Surveys and Gamma Radiation Measurements

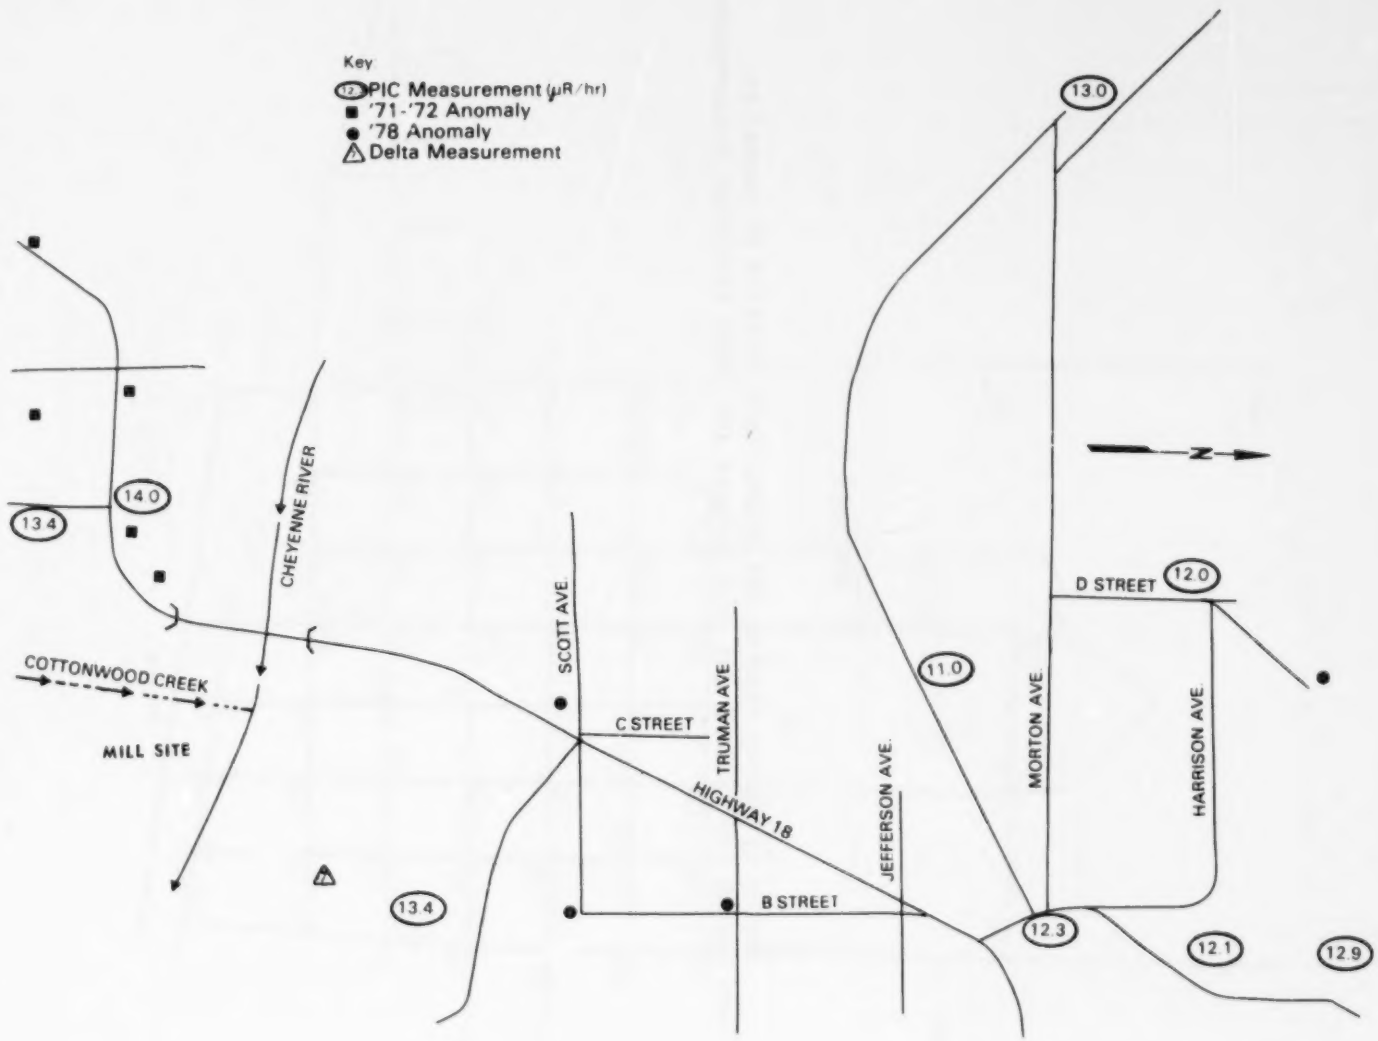
Figure C. Dudley

Sketch of Dudley Showing the Approximate Location of Anomalies
Found During the 1971-72 and 1978 Surveys and Gamma Radiation Measurements
